Manhole Inspection Summary

Manhole # S35YY1019MH

Insp Date: **2/5/07 9:28 AM**

Location Address: **309 THORNHILL RD**

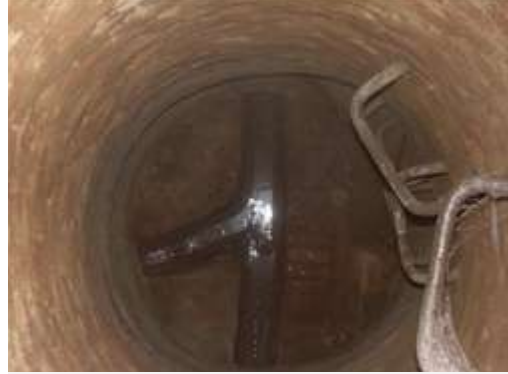
Top View

Evidence of surcharge - Bench debris.
Channel debris.

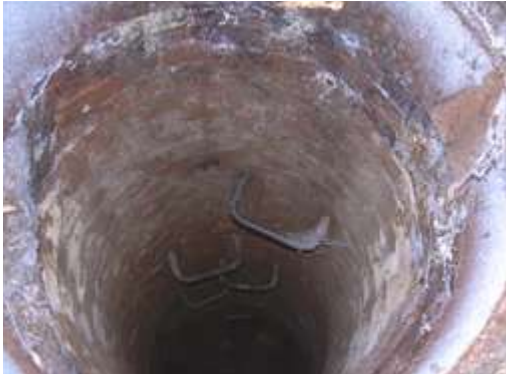
Defect

Frame leaks. Adjustment deterioration
and infiltration. Corbel and Barrel
infiltration - other side.

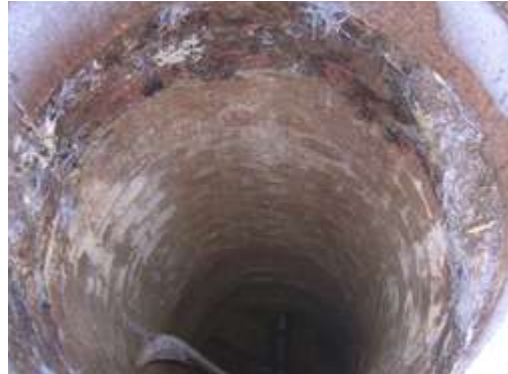
Defect

Frame leaks. Adjustment deterioration
and infiltration. Corbel and Barrel
infiltration.

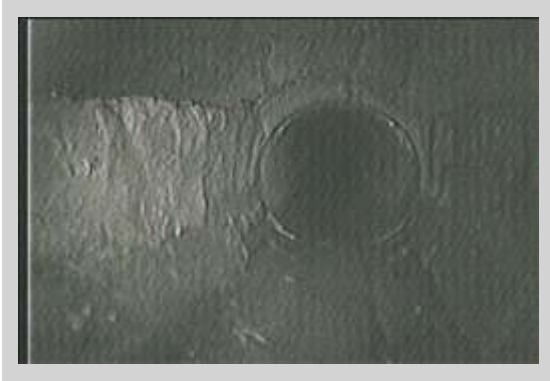
8 in. Circular Gravity Sewer Pipe Out @ 12 O'Clock

Barrel deterioration and infiltration. Channel deterioration.

Infiltration: **None** Pipe Seal Cond: **Cracked**

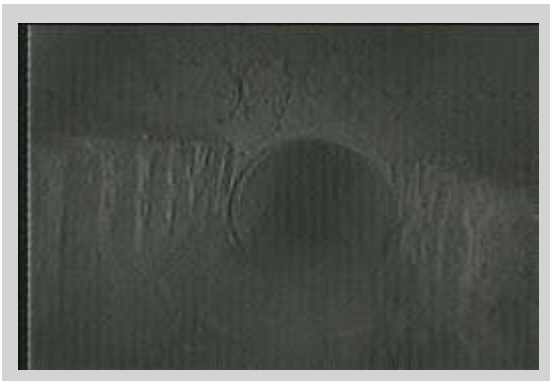
8 in. Circular Gravity Sewer Pipe In @ 6 O'Clock

Infiltration: **None** Pipe Seal Cond: **Cracked**
